## Callibration

From:  
<https://lavinia.as.arizona.edu/~tscopewiki/> - MOON

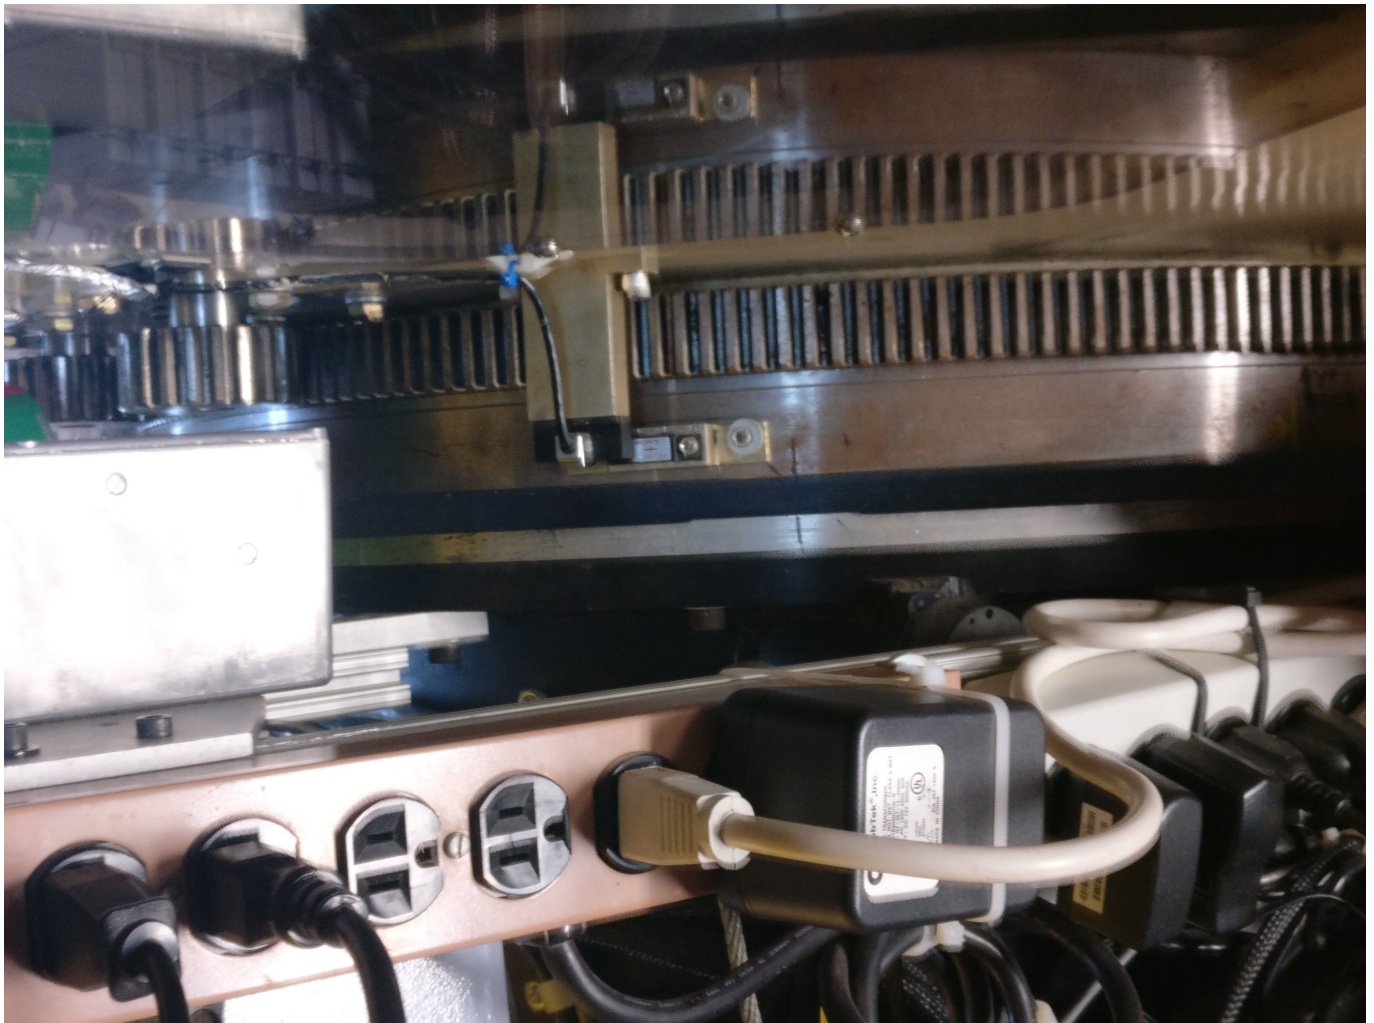
→ Do not move the derotator. Rather, carefully note its position in case you need to return it to that position (emergency stop, for instance). The correct position is shown in the image below.

A view of the derotator aligned taken from the hydraulic lift looking south
