# **MAESTRO Engineering Run July 24-31, 2007**

**To:** Faith Vilas  
**cc:** Russ Warner, Michelle Reed, Morag Hastie  
**From:** Jill Bechtold, on behalf of the MAESTRO team  
**Date:** Aug. 21, 2007

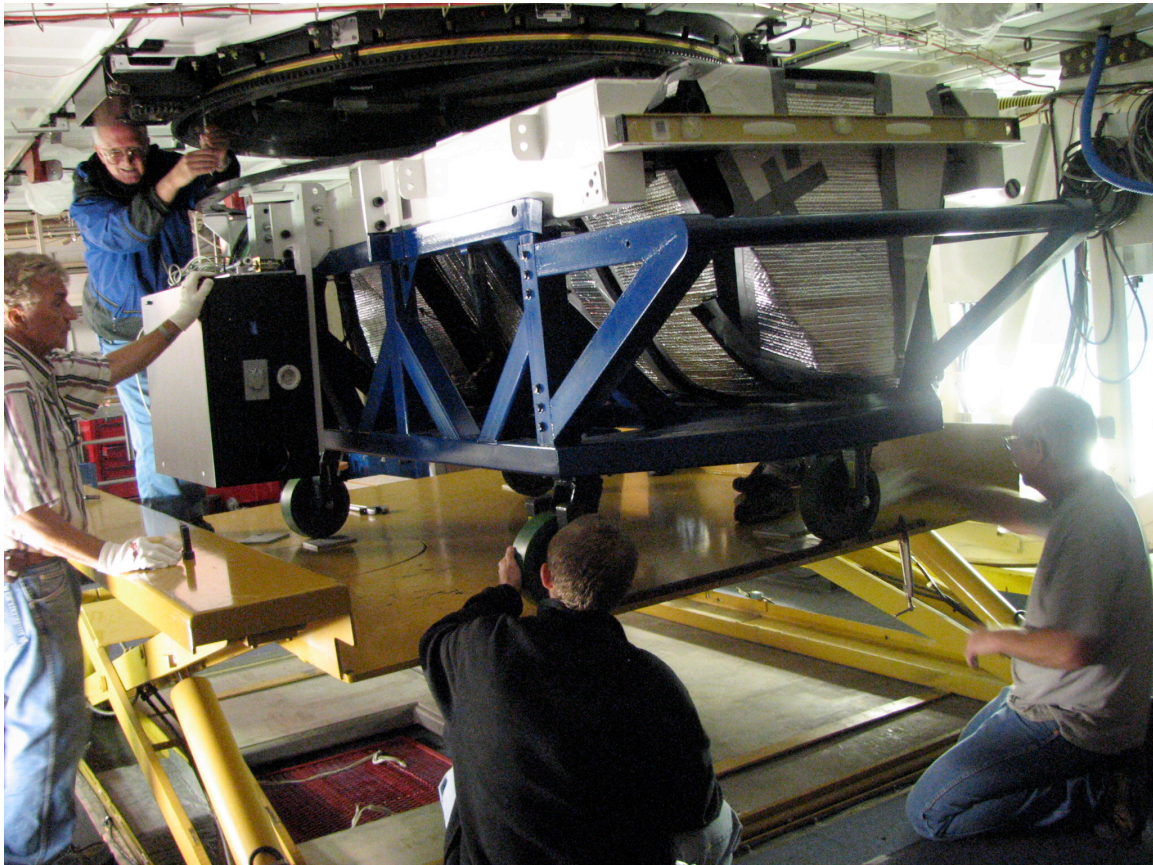
*MAESTRO on the instrument lift. The stop bar, in the foreground, is attached to the lift with a c-clamp.*

The spectrograph on the cart was lifted with the MMT instrument lift until the top of it was about 3 inches away from the rotator. A very small stop bar was attached to the instrument lift on the grating end of the spectrograph, to prevent the casters from rolling off the lift. However, when the spectrograph is aligned with the rotator, the casters are only a few mm from the edge of the lift, and the stop bar would have not offered much resistance, should the spectrograph start to roll off the lift. This situation caused great trepidation to the MAESTRO team, but was calmly dealt with by the MMTO staff.

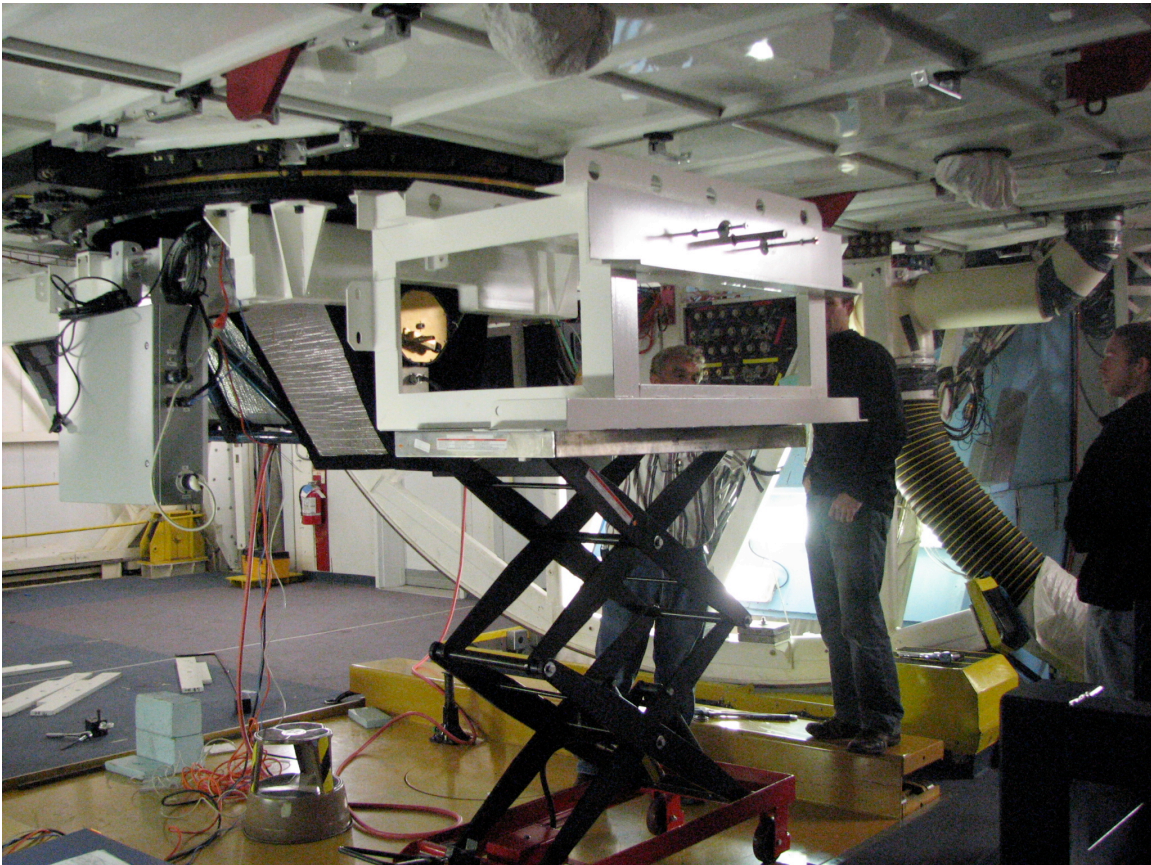
*Counterweights (white box-like structure) on scissor lift.*

The counterweights were then attached to the rotator. During our earlier dry run, this process had been problematic, and since then we had purchased a scissor lift to lift the counterweights to the rotator, without using the instrument lift. (We couldn't use an existing lift because none owned by the MMT could lift the heavy counterweights high enough). The counterweights cannot be lifted with the instrument lift because their CG is outside the footprint of the lift when the counterweights are attached to the rotator. The MMTO staff modified the cart and counterweights to provide stability during this process.

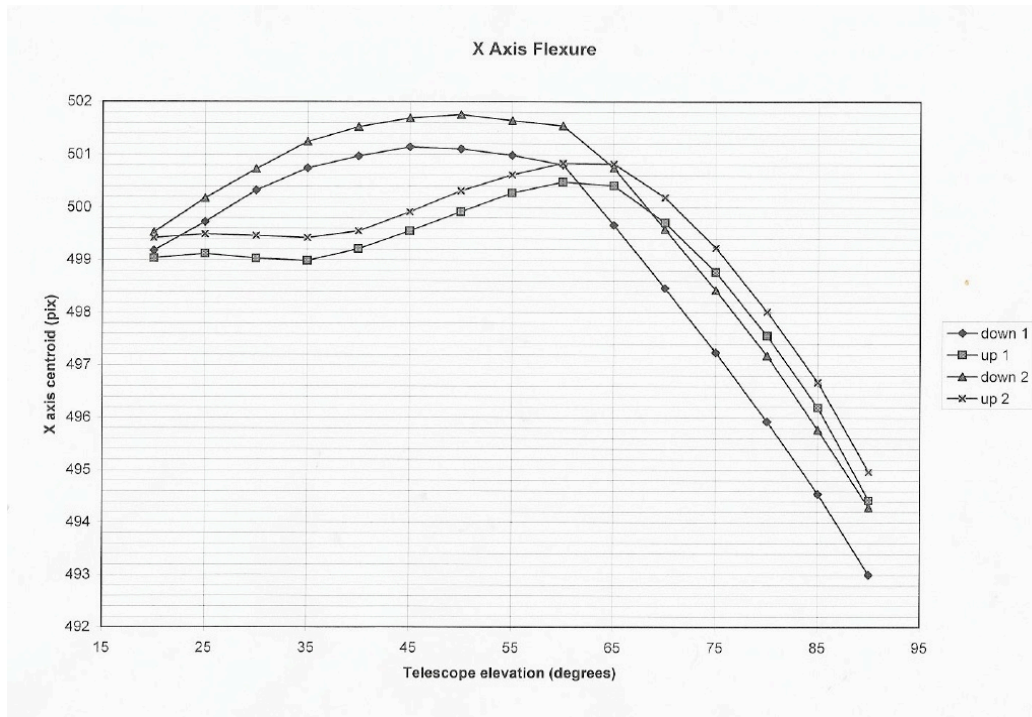
***MAESTRO flexure, measured with Th-Ar line centroid, in x-axis as a function of elevation, for two consecutive runs in elevation.***

One of the big challenges for MAESTRO was controlling flexure, to assure that any motion of the spectrum on the detector as an object is tracked across the sky could be calibrated out with lamps, given with the long exposures typical of high resolution spectroscopic observations. All other echelle spectrographs at large telescopes (> 4m) are located at Nasmyth or are bench mounted and fed by a fiber. In fact, review committees for NOAO/Gemini concluded that it is *impossible* for an echelle spectrograph like MAESTRO to be mounted at Cassegrain, because flexure would be intolerable. As the flexure tests for MAESTRO show, there is some hysteresis, but first order corrections may be possible with a look-up table. Even without a flexure map, long exposures will be possible at all elevation angles. The spectrograph focus is unchanged through all elevation angles. The tests shown below were carried out with the rotator set at the nominal 0 degrees, so that the slit is aligned with the parallactic angle. We started tests at other rotator angles on Sunday, July 29, but the shutter stopped working for elevation < 60 degrees, and the rotator set at 90 degrees.

In summary, the structural performance of MAESTRO is excellent. Aside from the shutter, everything works well at all elevation angles and we can rotate without problems.

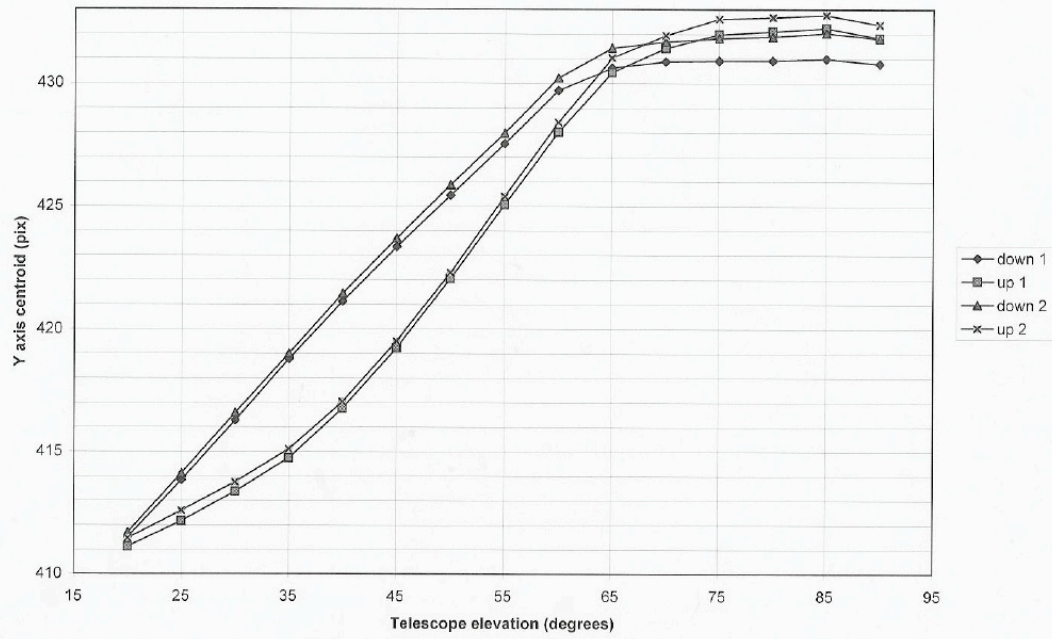
Y Axis Flexure

*Same as previous plot, but in y direction.*

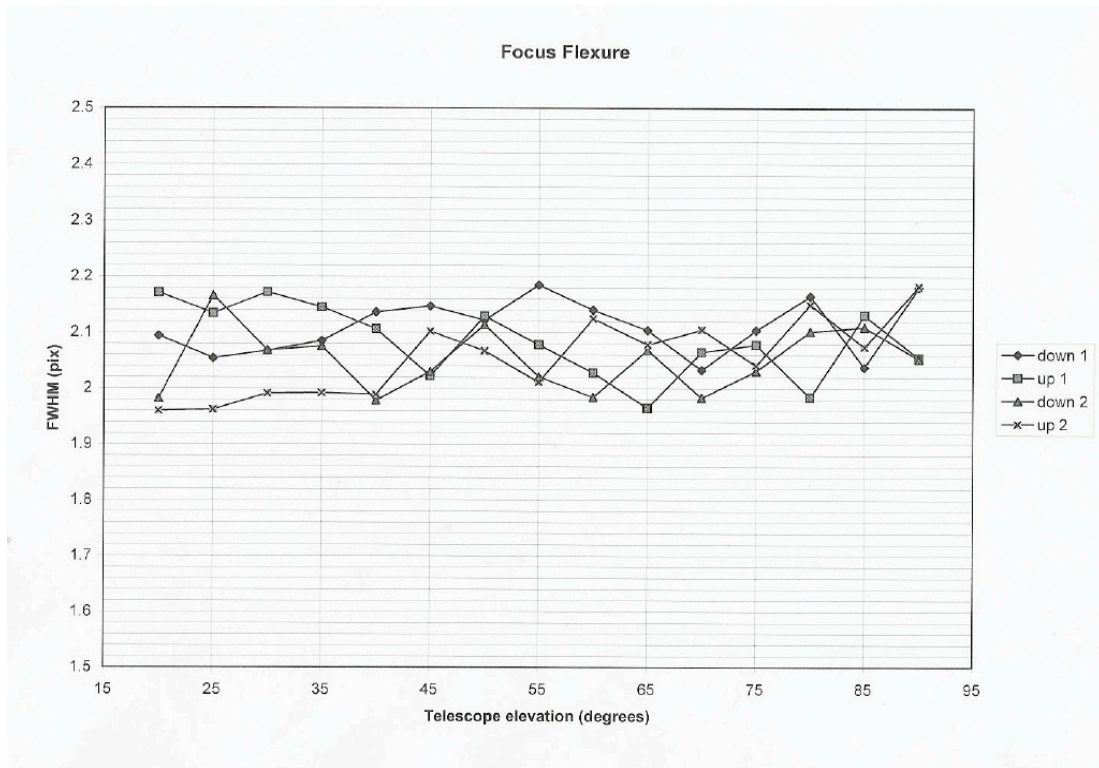
*No appreciable change in focus with elevation.*

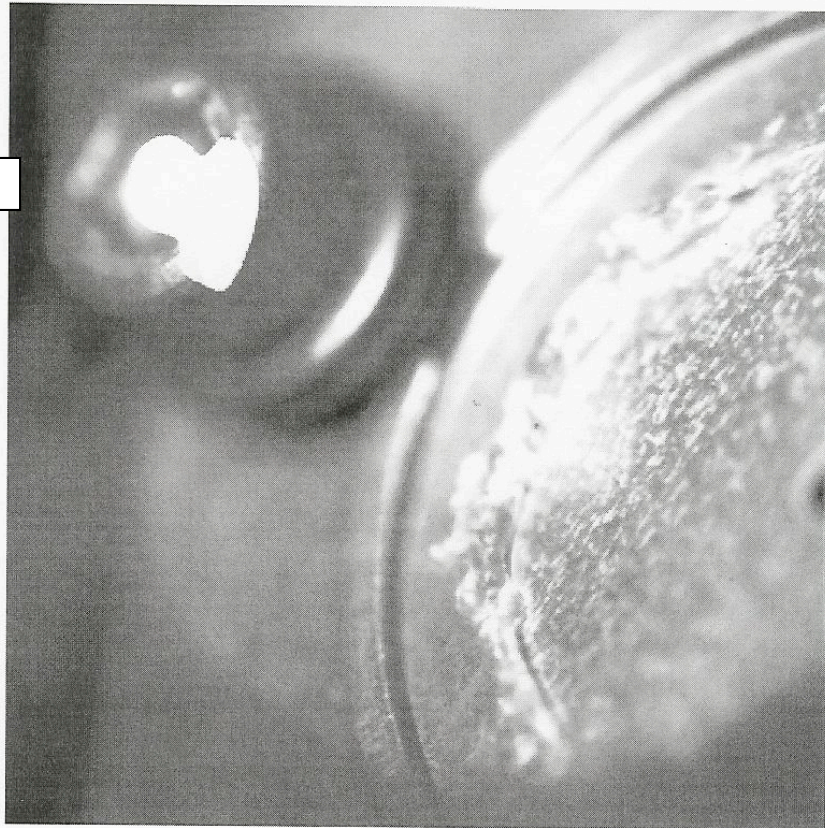
Mounting screw →

← Slit

*Image from slit viewer CCD. Here we have mounted a very large hole, for initial focusing and alignment. Although we are in focus, the slit should be in the middle of the CCD FOV.*

We were able to run the camera with slightly modified SO guider software on the “hoseclamp” computer. The CCD itself is read out on “maestroccd” using AZCAM. We focused the camera, but it is not pointing at the center of the slit plate. The FOV provided by the optics is what we anticipated, but we will need to realign it. It is impossible to access the camera when the spectrograph is mounted on the telescope. There is essentially no provision mechanically to point the camera, but we should be able to achieve this easily.

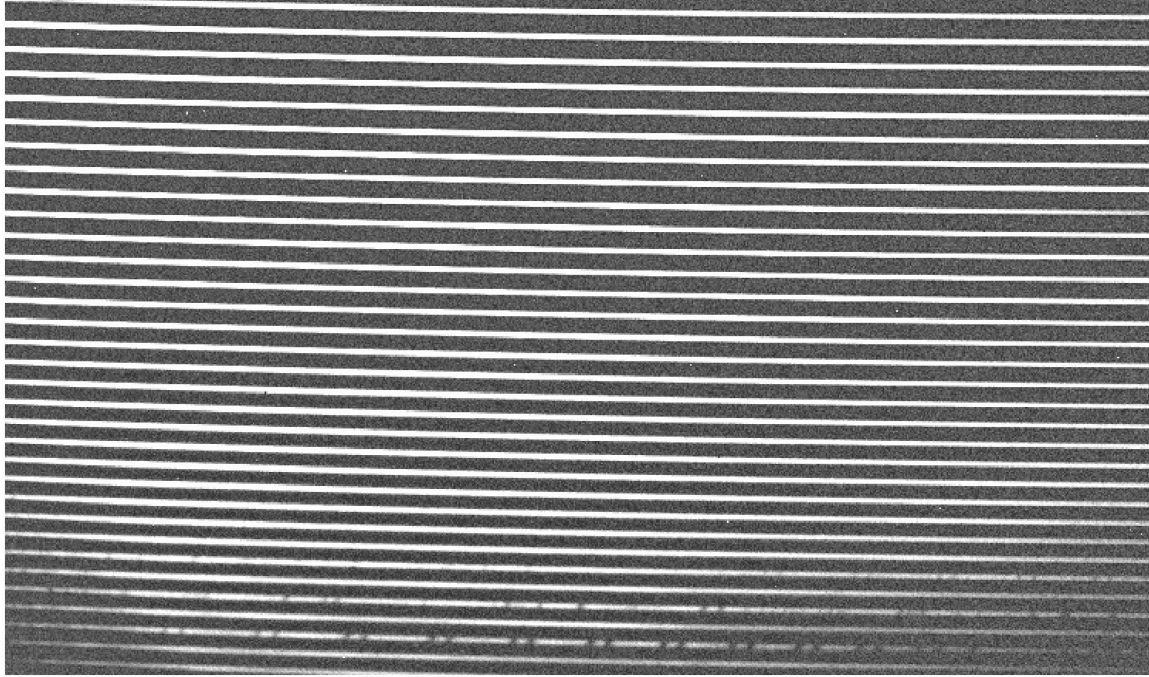
*Part of the spectrum of Vega, 5 minute exposure. Red orders are on the bottom. Telluric absorption bands are visible in the red.*

We finally were able to get Vega located on the slit and took an exposure (see below). We then went to a fainter (V=8) star which has very narrow ISM lines, to test the spectral resolution. However, we were unable to keep the star in the slit. We returned to Vega,

and obtained a few exposures. Thick clouds rolled in and out, and we sometimes could not see Vega in the guide camera. After about an hour, we gave up trying to observe, closed the dome, and did focus and flexure tests. However, the on-sky measurements showed that our slit is located within an arcsec of the telescope axis, better than we had hoped for.

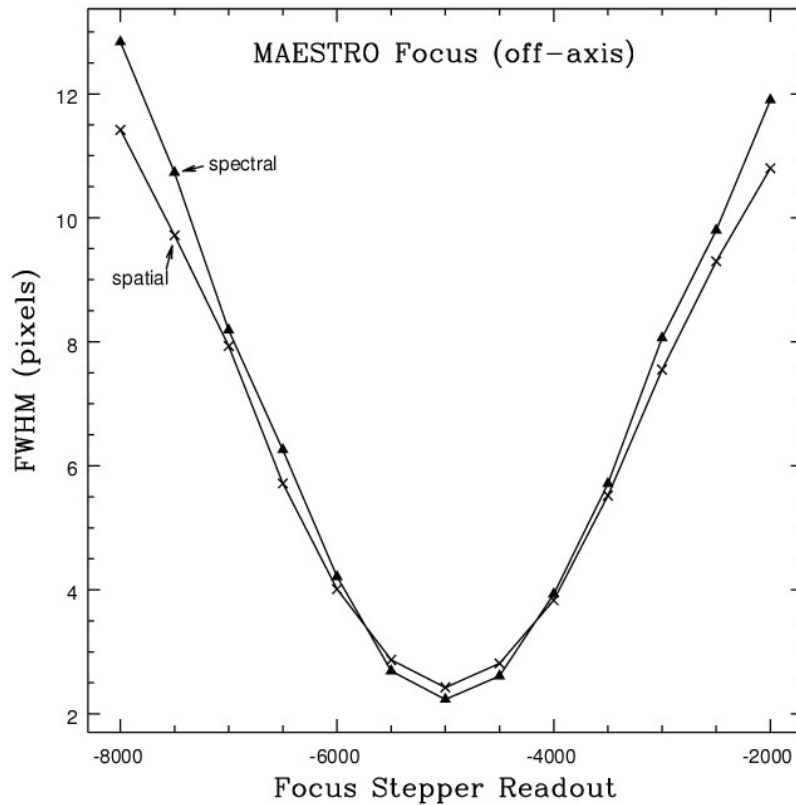
**FOCUS.** Focus tests on the telescope confirmed that the optical performance of MAESTRO is excellent. A series of Th-Ar spectra were taken, varying the position of L1, using the f/5 Th-Ar lamps and a 50 micron circle. The FWHM in the spatial and spectral directions is about 2.2 pixels, as predicted. There is no measurable astigmatism. The following plot uses a single thorium line, near the edge of the format, 80% of the total radius out from the optical axis. The excellent focus results are due to the work of Michelle Reed, who mounted and aligned the camera/collimator optics.

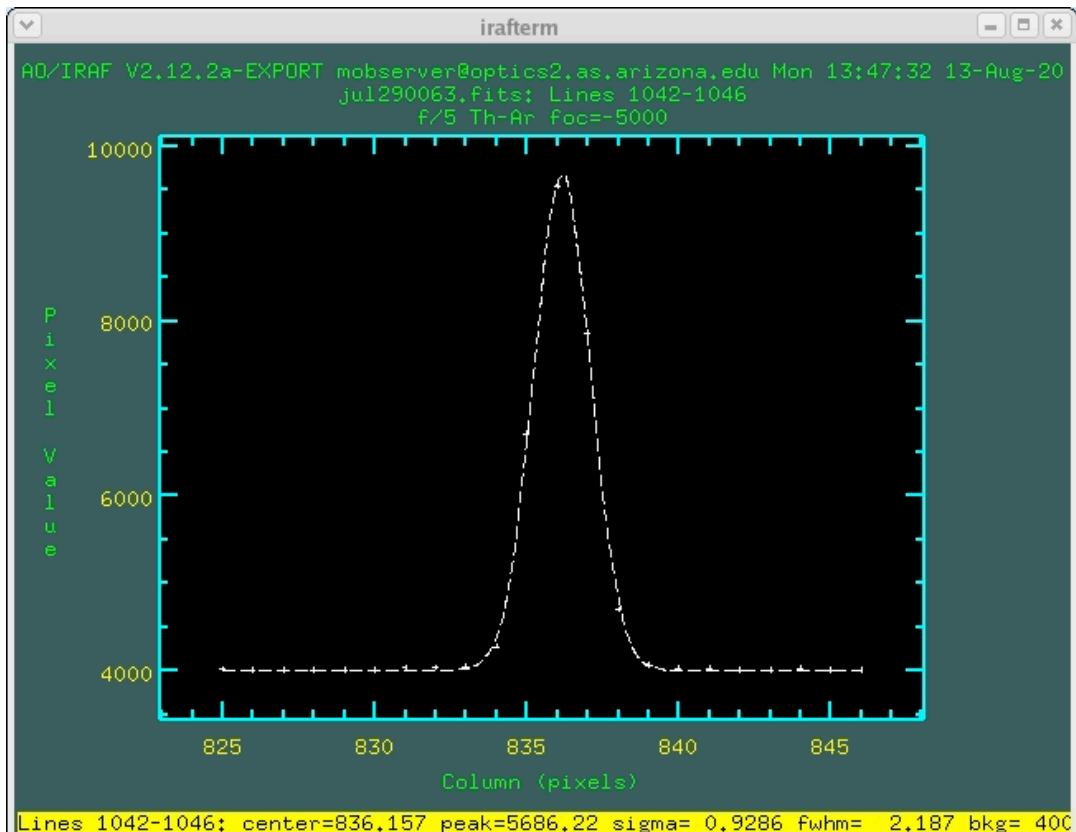
**SPECTRAL LINE FUNCTION.** The spectral line function is very nearly Gaussian – see plot below, which shows data (plus signs) and gaussian fit.

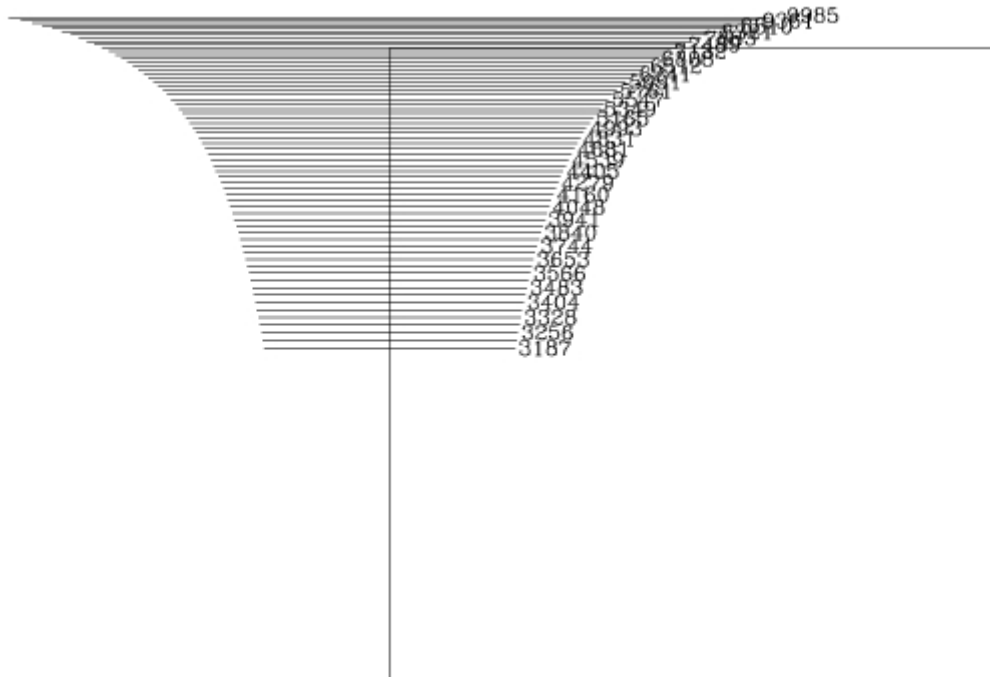
**Wavelength Coverage.** Due to the problems mounting the grating platform described above, we lose about half the spectrum off the detector. This is schematically shown in the figure, where I've plotted the free spectral range of the echelle format and a square to indicate the footprint of the detector.

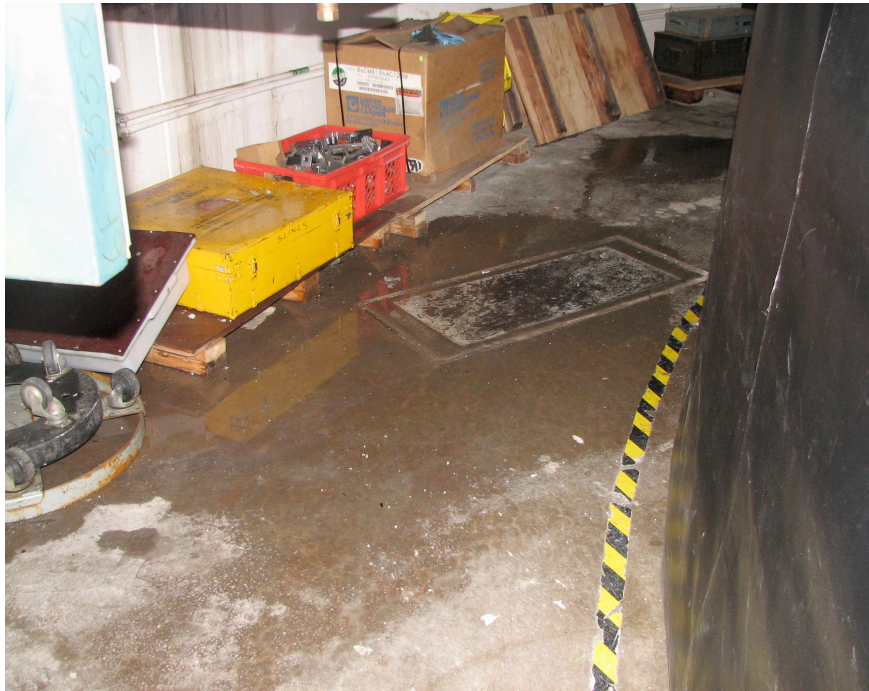
*A puddle on the floor of the pit, where MAESTRO is to be stored.*

In fact, there really is no place on the mountain to set up MAESTRO to work on it except in the Pit. The pit is really not a nice place to work: it floods when it rains (see below), there is oil in the air so the enclosure must be filtered, and one needs to lower personnel and equipment down a ladder. Moreover, the MMTO staff were replacing the floor in the chamber, a very messy job, and they were glad to take MAESTRO downtown, since they needed to move as many instruments as possible to the pit during construction.
